ST ISHMAEL DESERTED MEDIEVAL VILLAGE, CARMARTHENSHIRE ARCHAEOLOGICAL INVESTIGATIONS 2017 INTERIM REPORT

RHIF YR ADRODDIAD / REPORT NO. 2017/62
RHIF Y DIGWYDDIAD / EVENT RECORD NO. 111141

CADW PROJECT NO. DAT 147

Mawrth 2018
March 2018

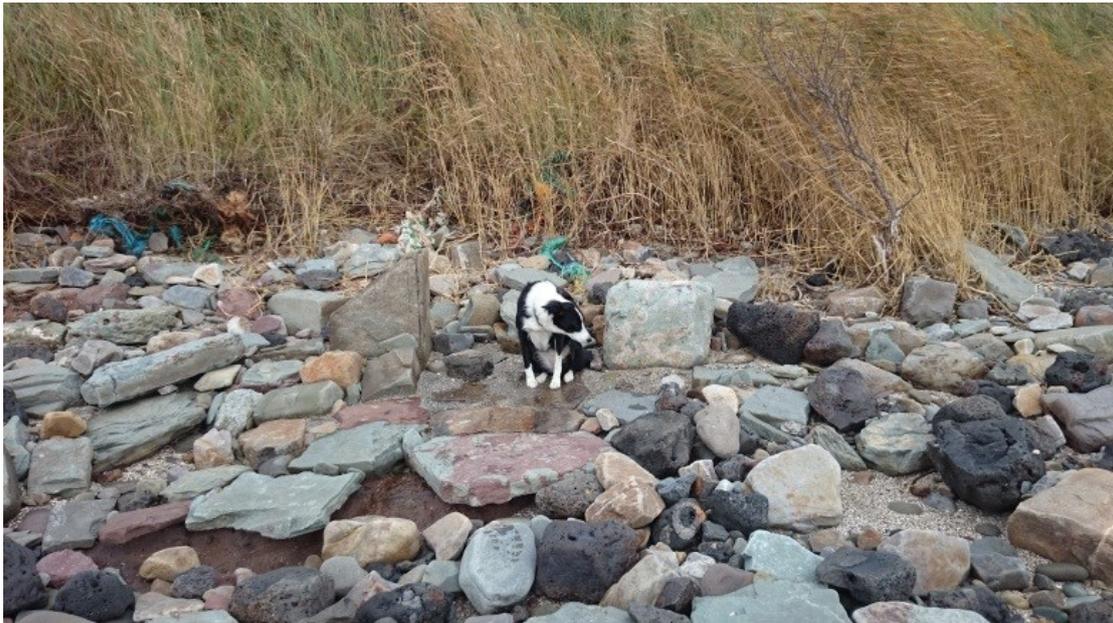
Photo 1: Doorway to a Building 6 identified at the base of the dunes in October 2014

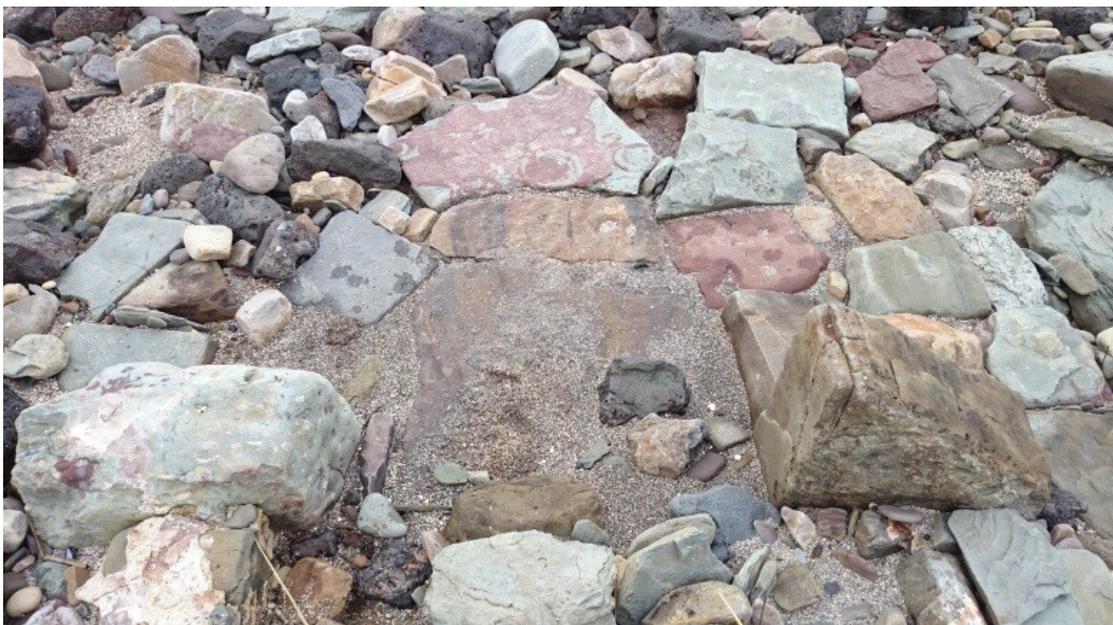
Photo 2: View from above of the doorway to Building 6, showing an almost semi-circular area of stone slabs in front of the door opening

slabs were of both red and blue/green local sandstones. The semi-circular arranged slabs had suffered erosion since it was seen in 2014 (Photo 2).

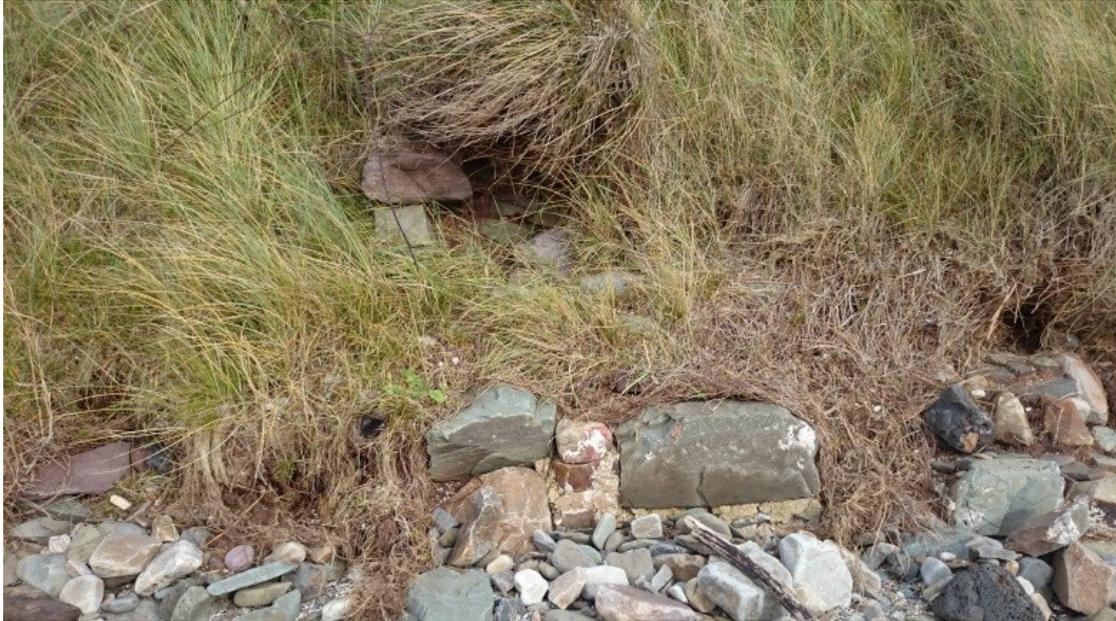
Photo 3: Walls of Buildings 5 and 6 in October 2014 located along the base of the dune, with perpendicular wall running into the dune

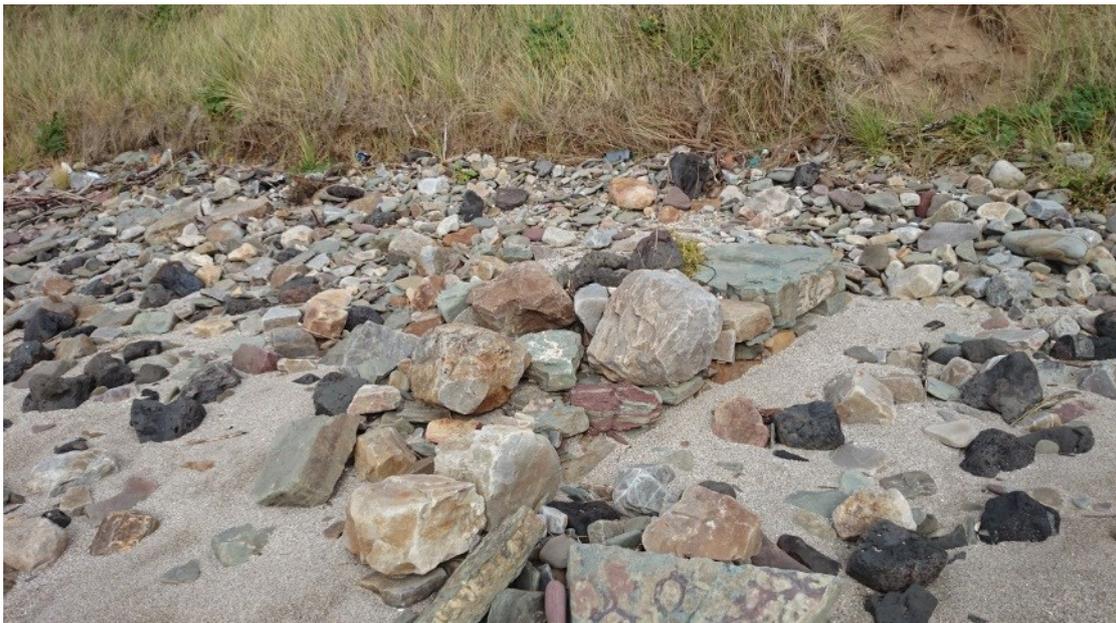
Photo 4: Walls exposed of Building 7 beneath the shingle on the foreshore in October 2014

3.7.1 Building 7 was identified as a series of remnant wall lines within the dunes (Photo 4). Following clearance of the shingle from above and within the walls a clear building outline was identified, with only the northeastern corner still covered by the sand dunes. The entire western (Photo 15) and southern walls were exposed, with partial exposure of the northern and eastern walls (Figures 4 and 5). No doorway could be identified with the exposed walls that would be similar to those seen in Buildings 2 and 6.

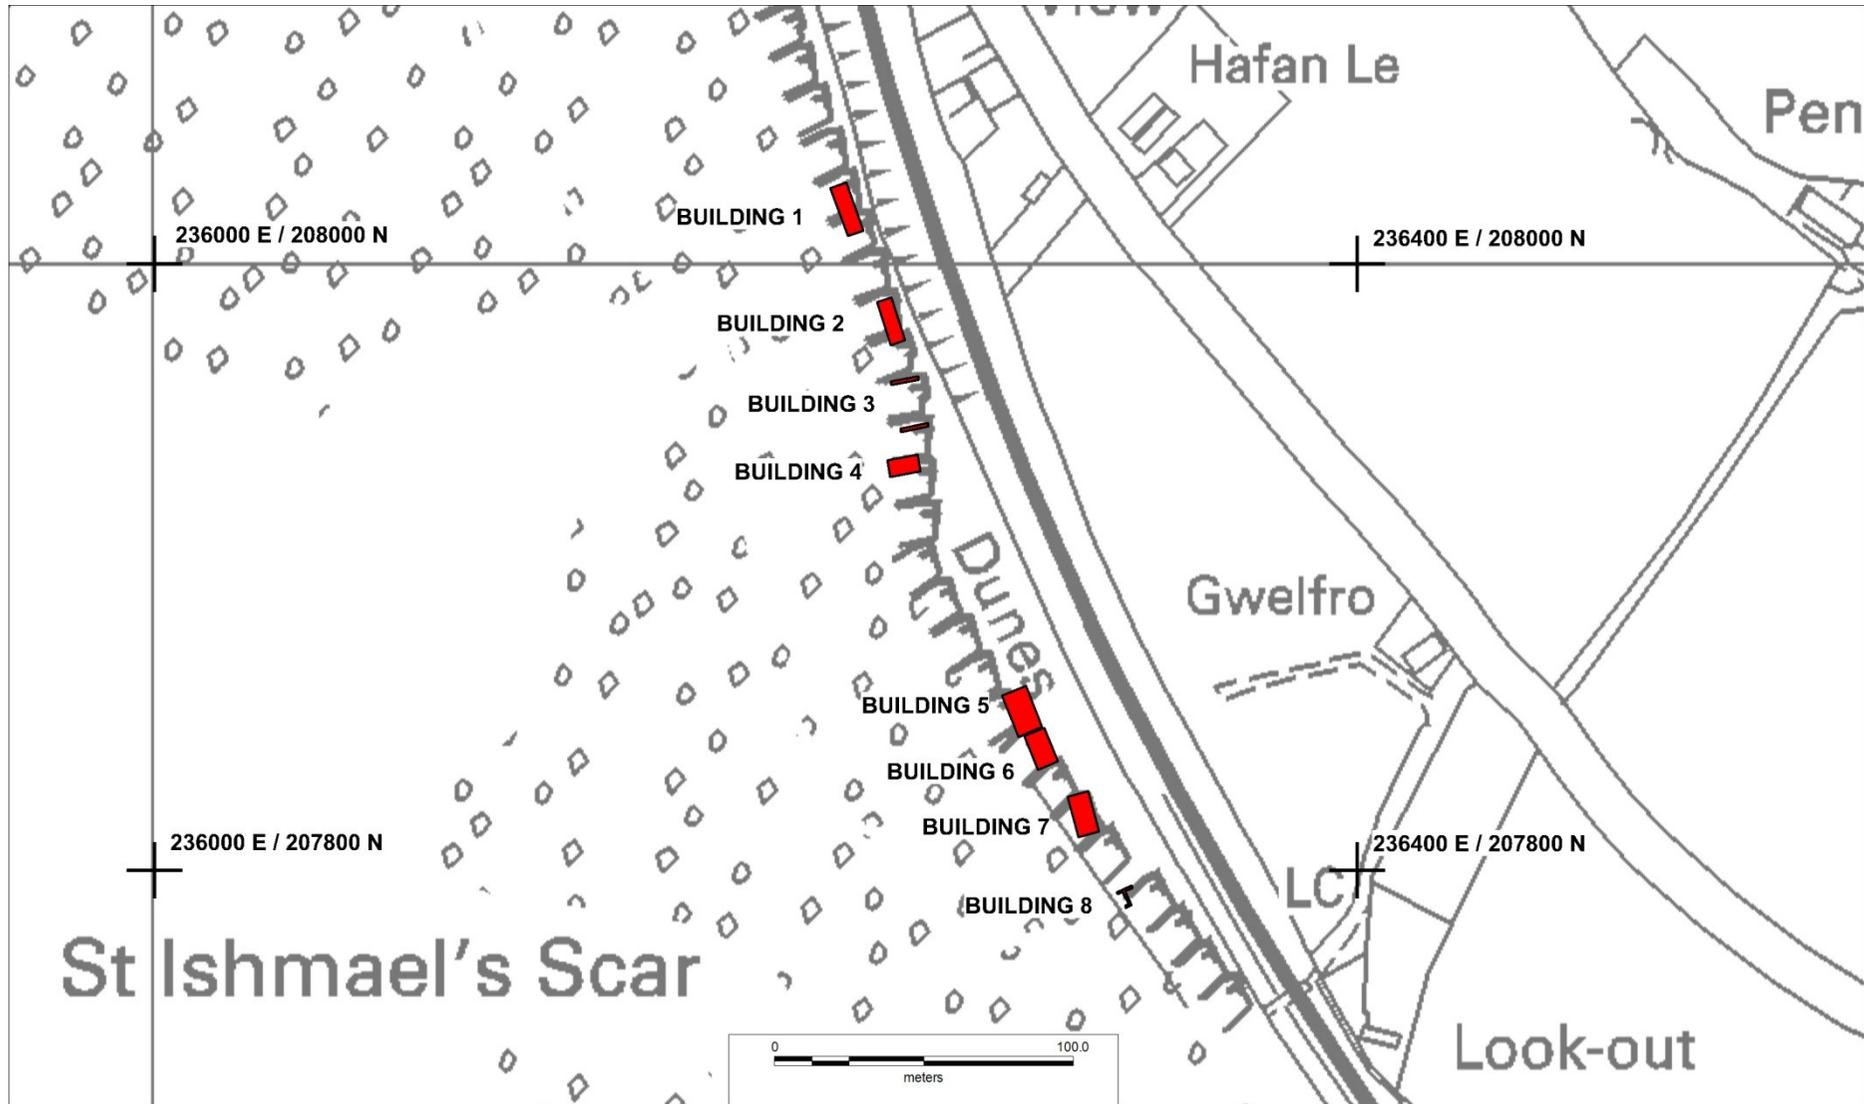
Figure 2: Approximate layout of identified buildings since 2010 overlain on 1:10000 Ordnance Survey map

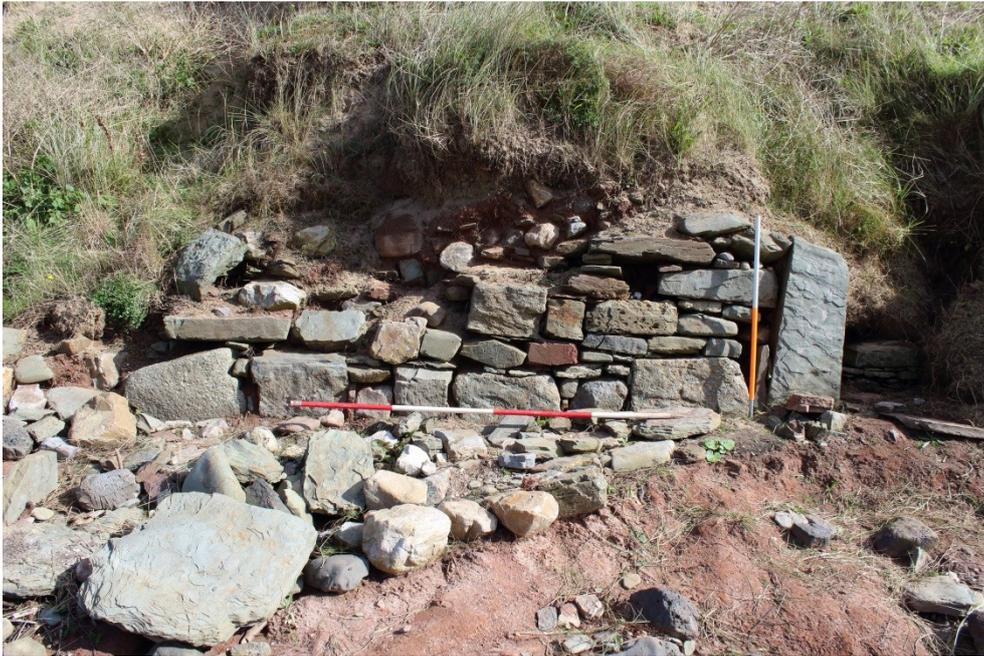
3.1.1 Building 1 was the most northerly structure originally identified and recorded in 2010 and 2011 when only the east to west aligned walls to the north, south and middle of the building were visible. The eastern (rear) walls of the building had been exposed to a maximum height of 1m (Photos 5 and 6). A second doorway leading to the east has also been revealed, which had been partially blocked with a (presumably) later wall (Photo 6). Erosion of the east to west aligned walls has been quite extensive and little survives.

Photo 5: Rear wall of Building 1, northern half

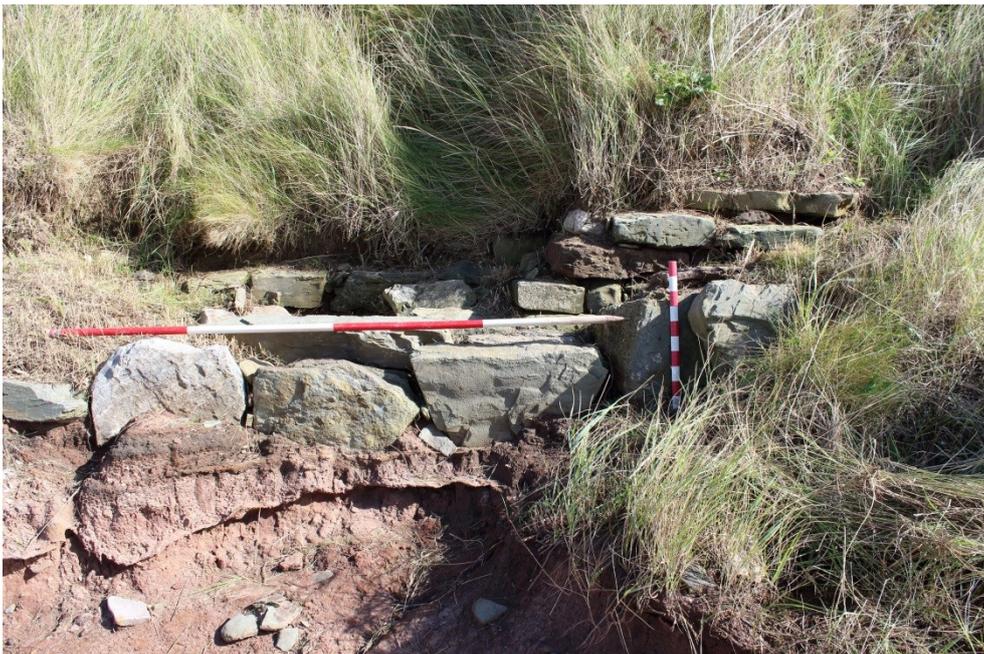
Photo 6: Rear wall of Building 1, southern half

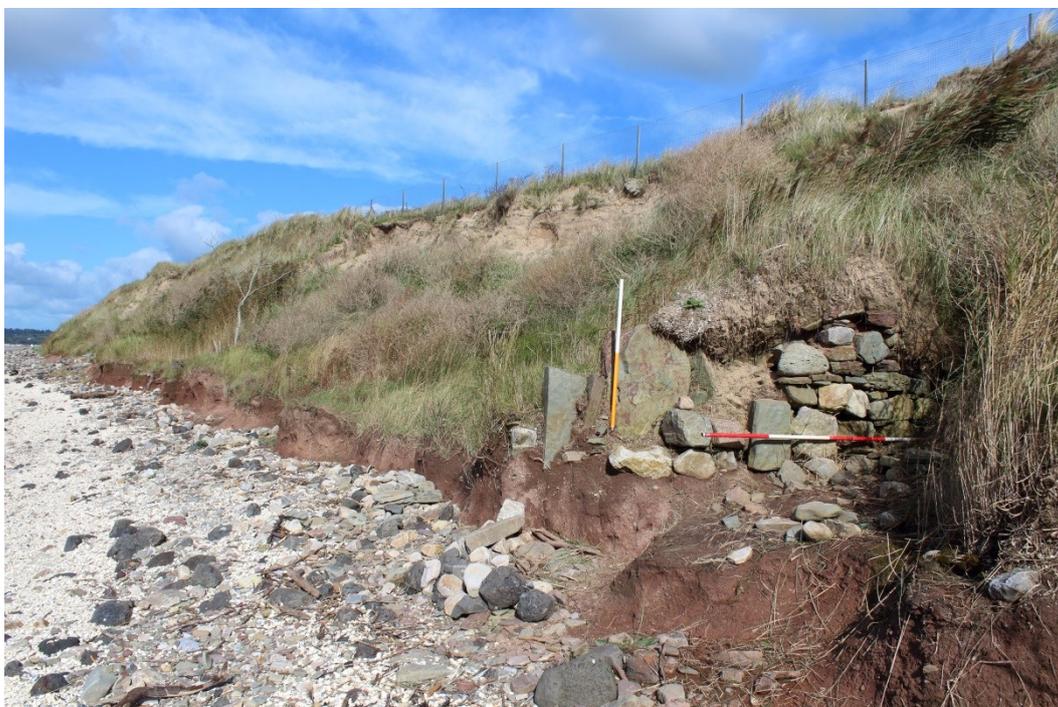
- 3.2.1 Building 2 has suffered significant erosion since 2011. The entire front wall of the structure, including the doorway has been lost to coastal erosion. Two small upright stones form the line of upright stones noted inside the western wall of the building survive.
- 3.2.2 The presumed southern gable end wall of the structure does still survive to around 1m height in the dunes (Photo 7), but otherwise almost all surviving fabric has been lost or remains hidden beneath the dunes.
- 3.2.3 Significant collapses of dune sands have eroded in the area of Building 2 such that they have now exposed the footings for the boundary fence for the West Wales railway line (Photo 7).
- 3.2.4 One of the former upright stones that formed the doorway for the building was identified on the lower foreshore some 50m north of the remains of the building.

Photo 7: View northeast across the site of Building 2 showing the southern gable end wall and the dune collapse to the railway fence line behind

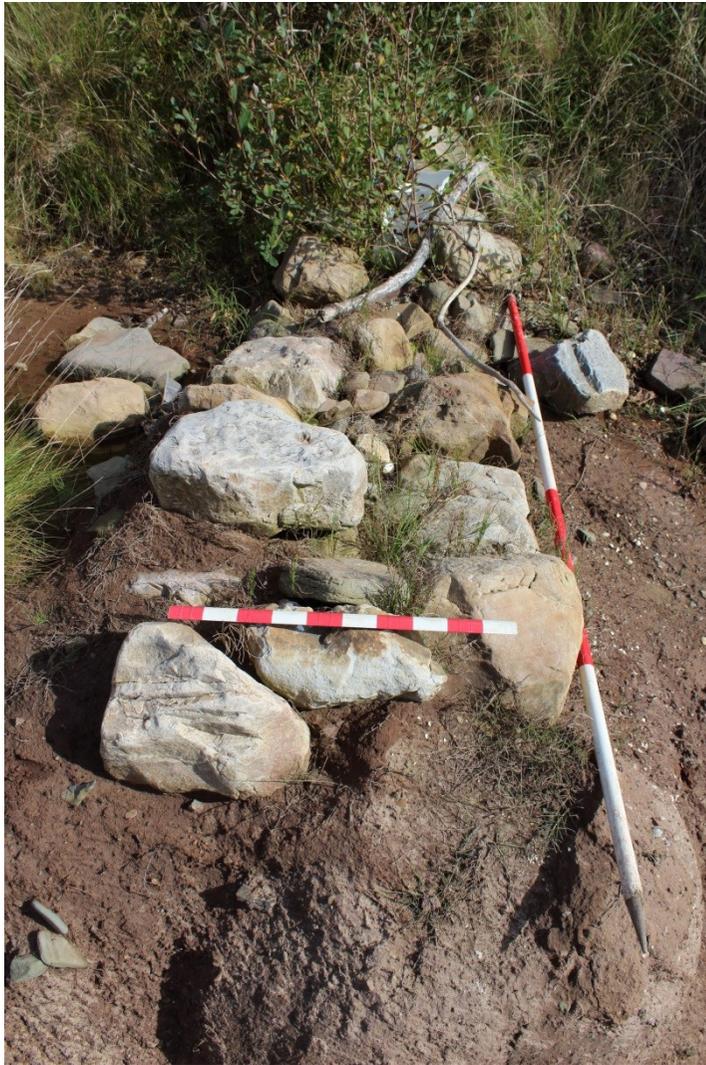
- 3.3.1 The two walls initially identified as the north and south gable end walls of a third building have suffered further erosion. The southern of the two walls has been exposed on top of the clays underlying the dunes for a length of around 2m, but it only survives to a maximum of three rough courses in height (Photo 8). The northern wall survived in a very poor state of preservation. These may actually be boundary walls rather than building remains, but this cannot be confirmed.

Photo 8: Southern wall of possible Building 3 exposed on clay layer beneath dunes

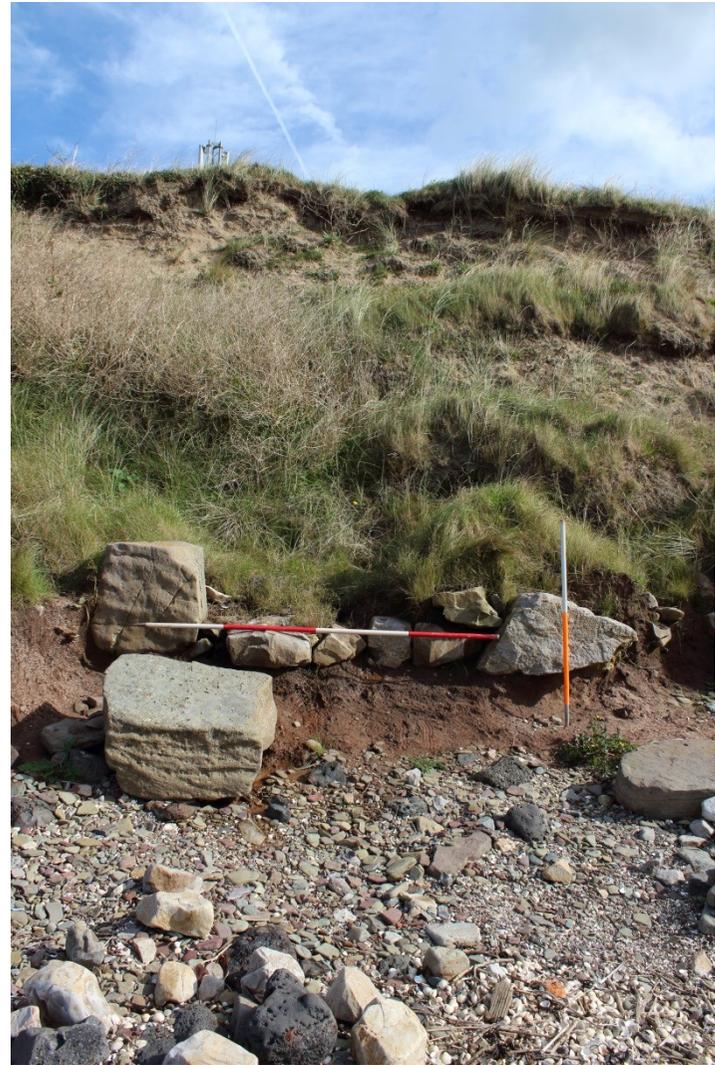
Photo 9: Surviving remains of eastern end wall of Building 4

3.4.1 The remains of the eastern end of Building 4 have been steadily eroding over many years. Only a small part of the lower, outer course of stones for the rear wall survive, including two of the substantial corner stones (Photo 9). One of these larger foundation blocks for the northern wall has eroded and lies on the foreshore in front of the building remains (Photo 9).

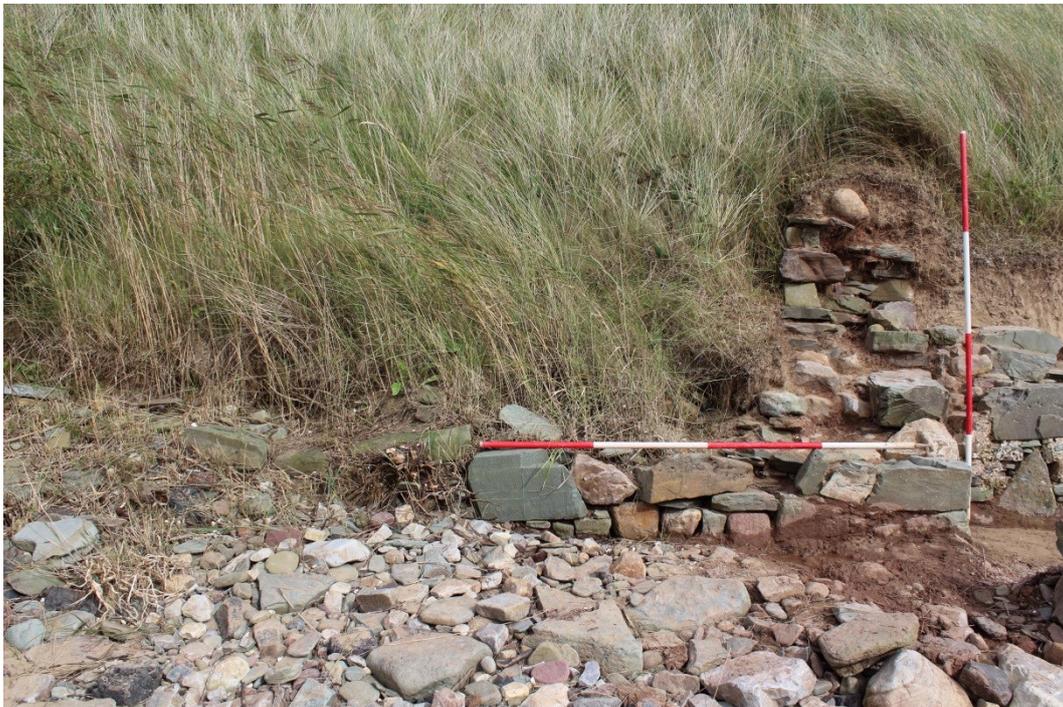
3.5.2 The southern gable end wall of this structure has been partially exposed in the dune to a visible height of around 1.8m height (Photo 10). The visible length of the western wall ran north for around 5m before it was completely invisible in the vegetation and sand dunes.

Photo 10: Southwestern corner of Building 5 exposed at the base of the sand dunes, with substantial height of surviving gable end wall visible

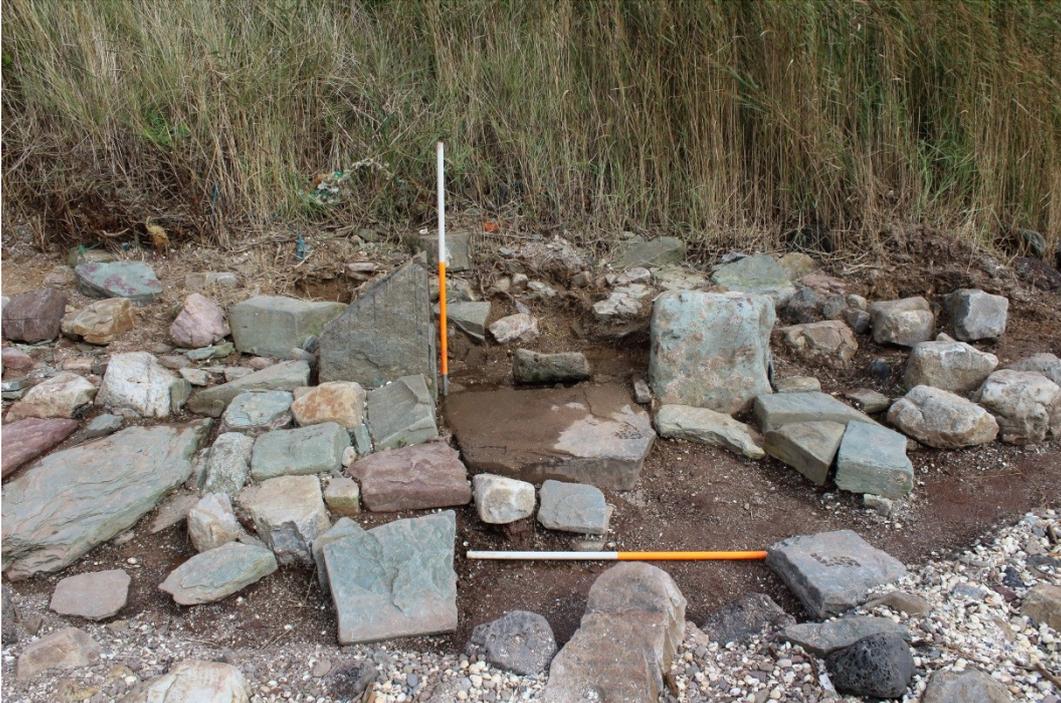
3.6.1 This lay adjoining Building 5 on its southern side. It comprised a 12m length of wall on its western side, with a slightly off centre doorway formed by two larger stone blocks. A large stone slab formed the threshold into the building, which was surrounded by a roughly semi-circular formation of stone slabs around it. Further stone slabs ran along the outside of the western wall on the northern side of the doorway. The

Photo 11: Entrance way into Building 6 with remains of semi-circular stone slab arrangement visible in front

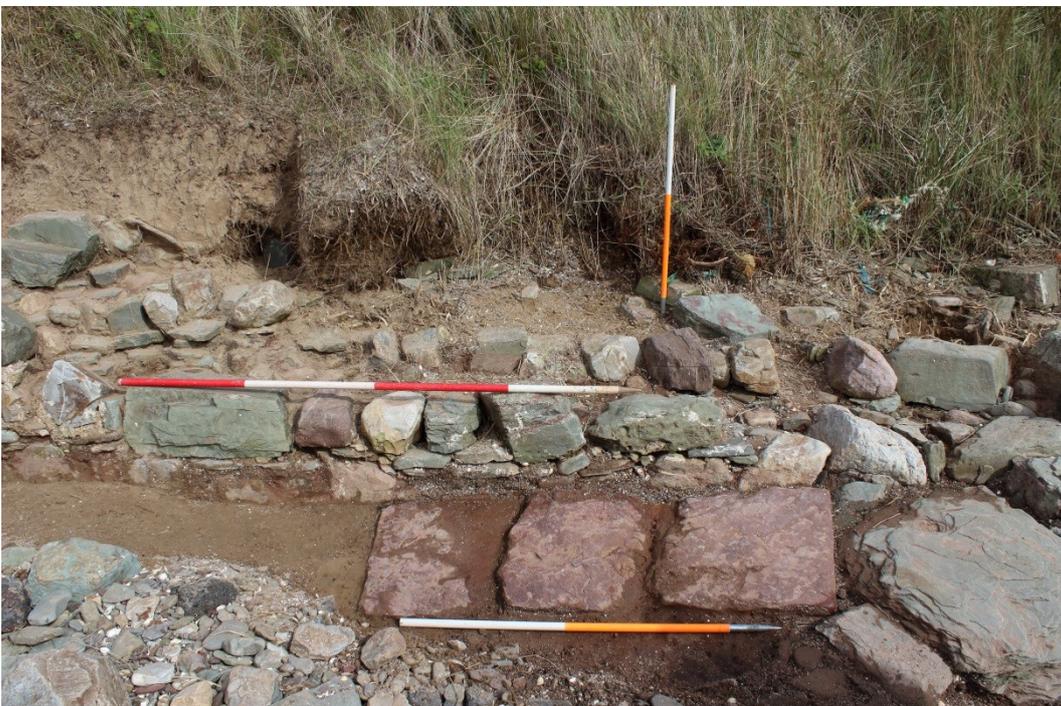
Photo 12: Sandstone slabs north of the entrance way of Building 6 and western wall

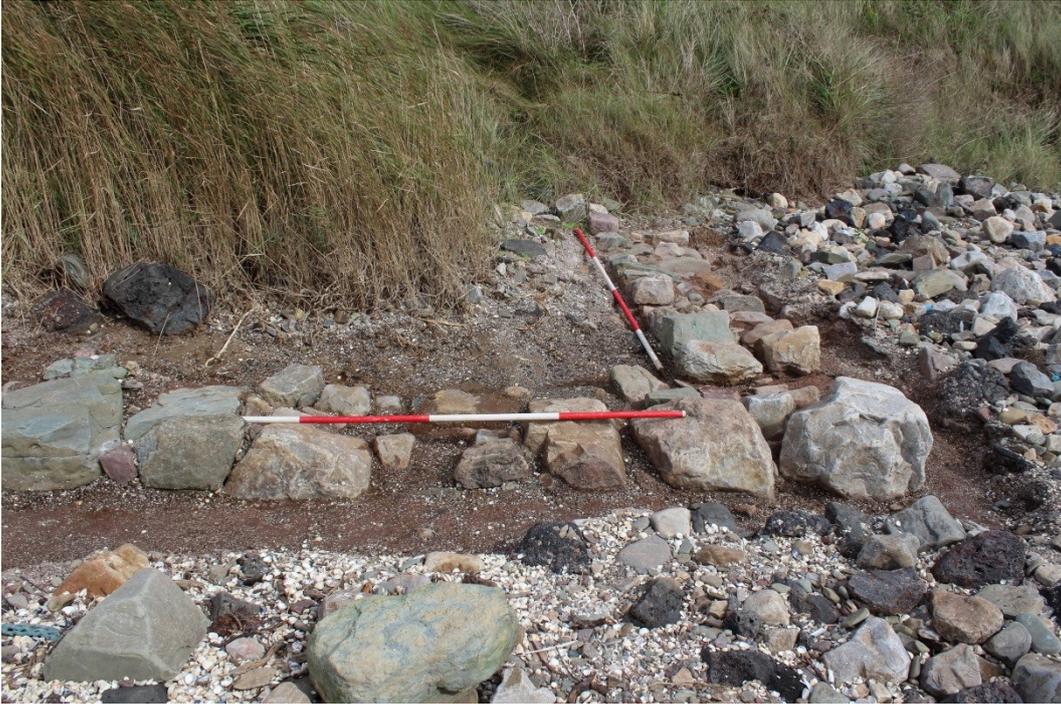
3.6.2 The southern wall of the building was exposed beneath the shingle and confirming the southwestern corner (Photos 13 and 14). In total the structure was 12m in length.

Photo 13: Southwestern corner of Building 6 with southern wall running east into sand dunes

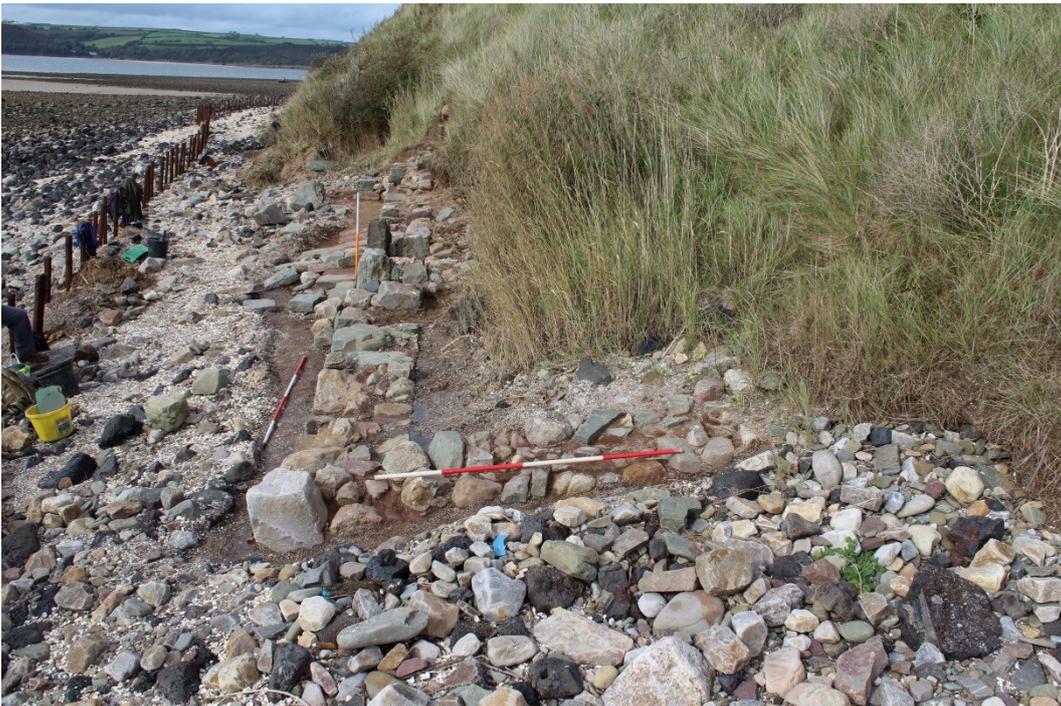
Photo 14: View north along Building 6 showing southwestern corner of structure and entrance way

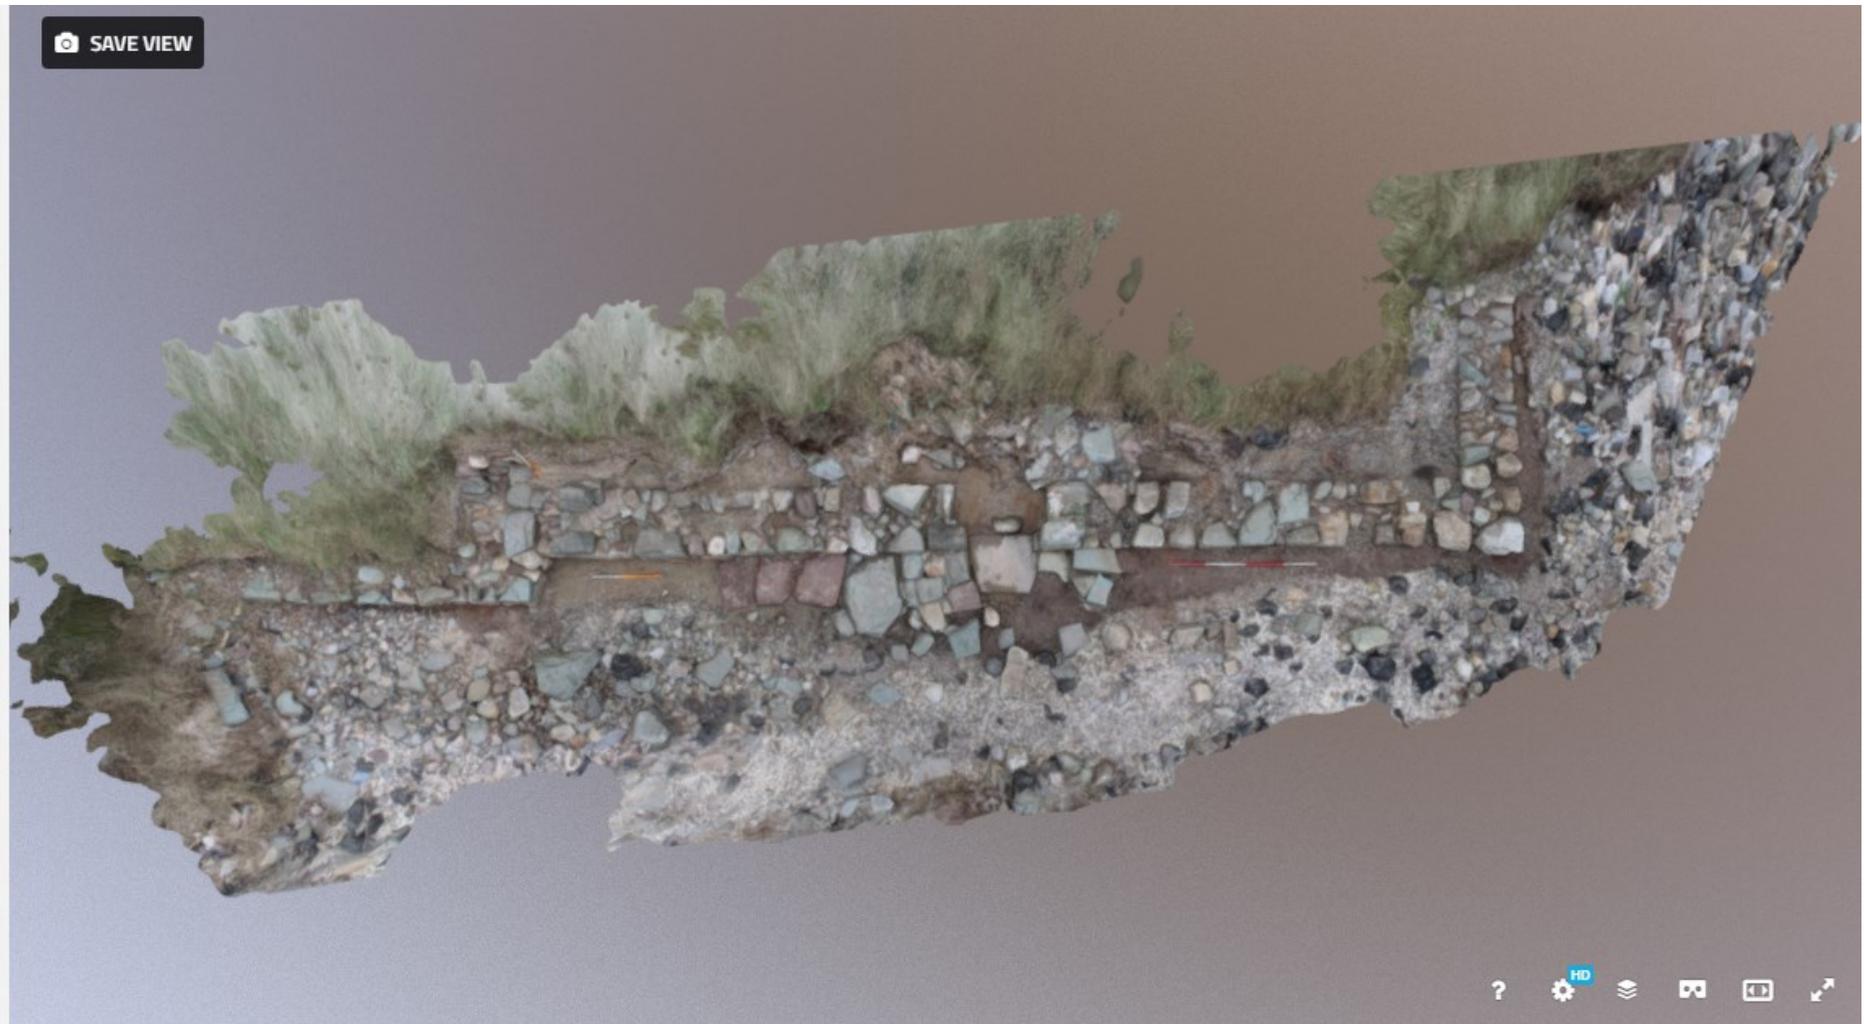
- 3.6.3 Building 6 was the only structure so far identified at the site which has clearly used mortar for bonding the stonework.
- 3.6.4 A photogrammetric model of the building was produced, from which the following image has been taken (Figure 3).

Figure 3: Photogrammetric model of Building 6 and part of Building 5 (to left) creating a virtual aerial view of the Buildings
Viewable via Sketchfab website <https://skfb.ly/69v97>

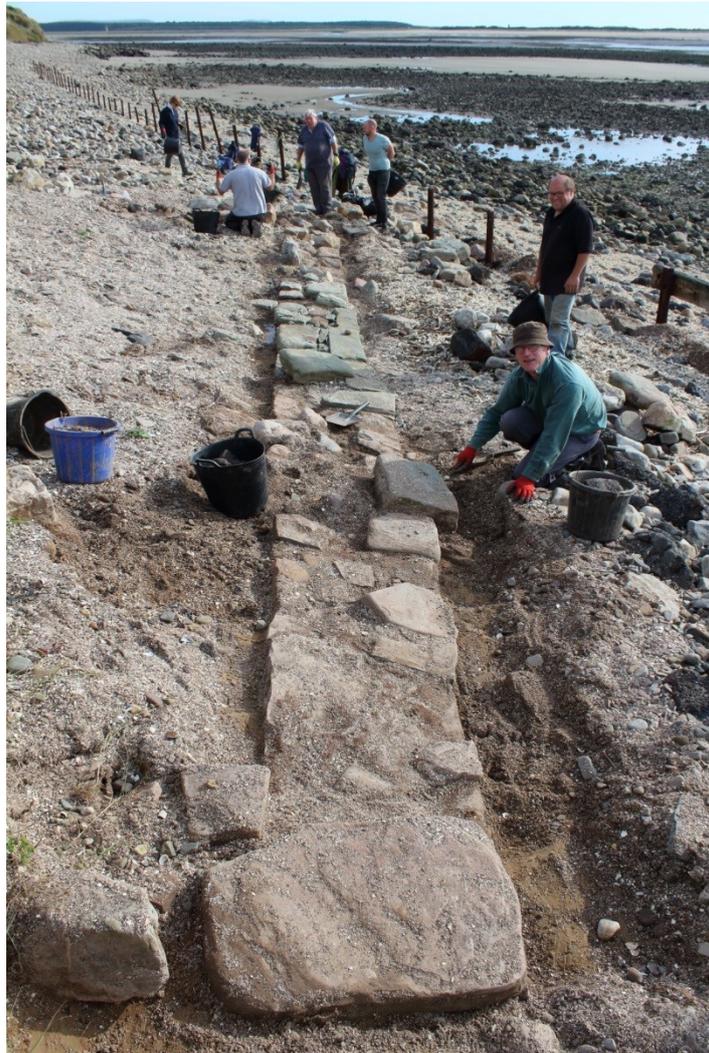
Photo 15: Western wall of Building 7 being exposed, viewing south

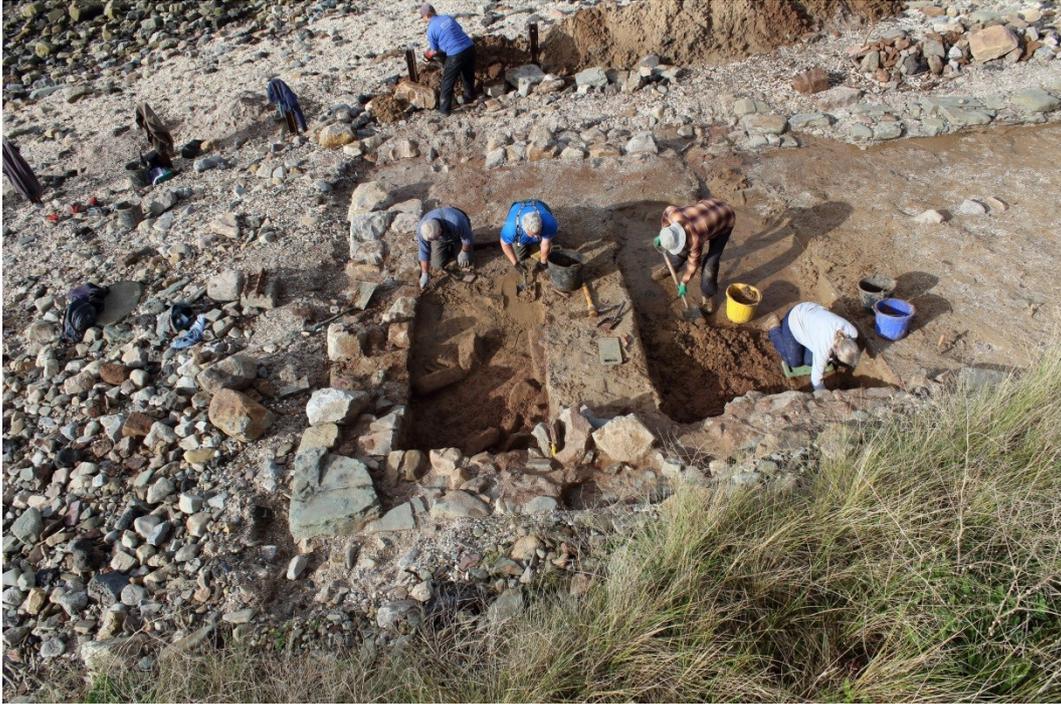
- 3.7.2 Partial excavation was undertaken within the southern end of the building to determine the depth of the surviving walls and whether any floors survived (Photo 16). As the foreshore slopes west towards the sea it was unsurprising that the depth of surviving wall was greater to the east at a height of almost 1m (Photo 17).
- 3.7.3 This building was again around 12m in length (like Building 6) and with a width of just over 6m between the outer faces of the east and west walls.

Photo 16: View from sand dunes of the partial excavation of the southern end of Building 7

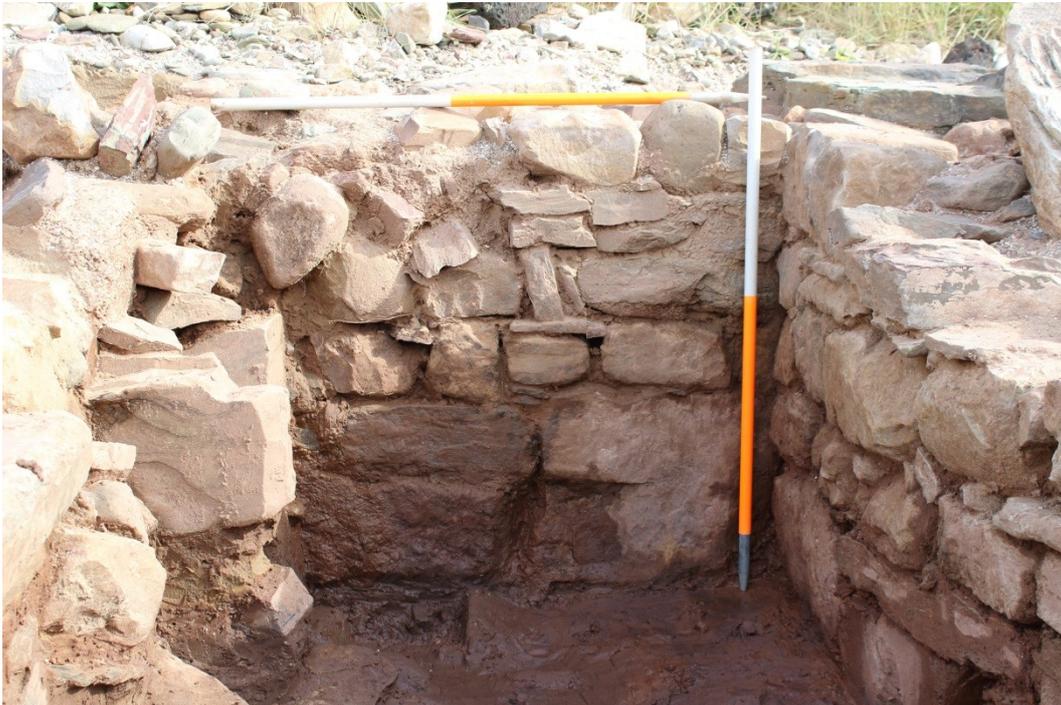
Photo 17: Southeastern corner within Building 7 showing height of surviving eastern wall

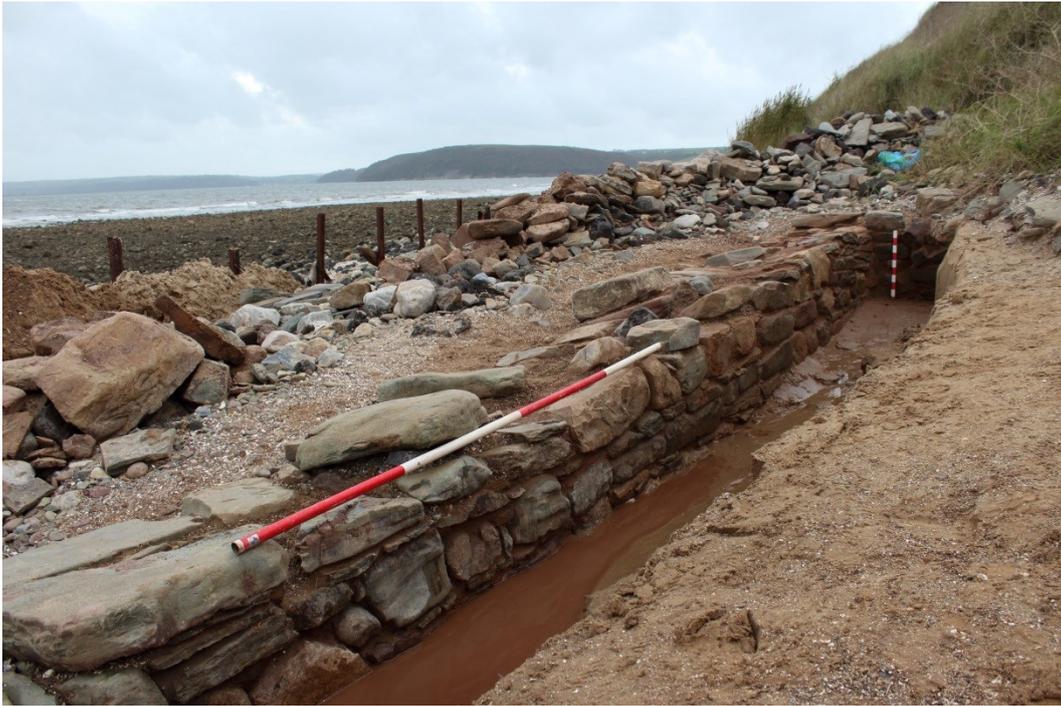
3.7.4 The inside of the western wall was also partially excavated and exposed, but due to water ingress and sand accumulation it was not possible to bottom the wall. A height of 0.55m of wall was exposed (Photo 18).

Photo 18: View along inside of exposed western wall to the northwestern corner of Building 7 showing height of surviving eastern walls

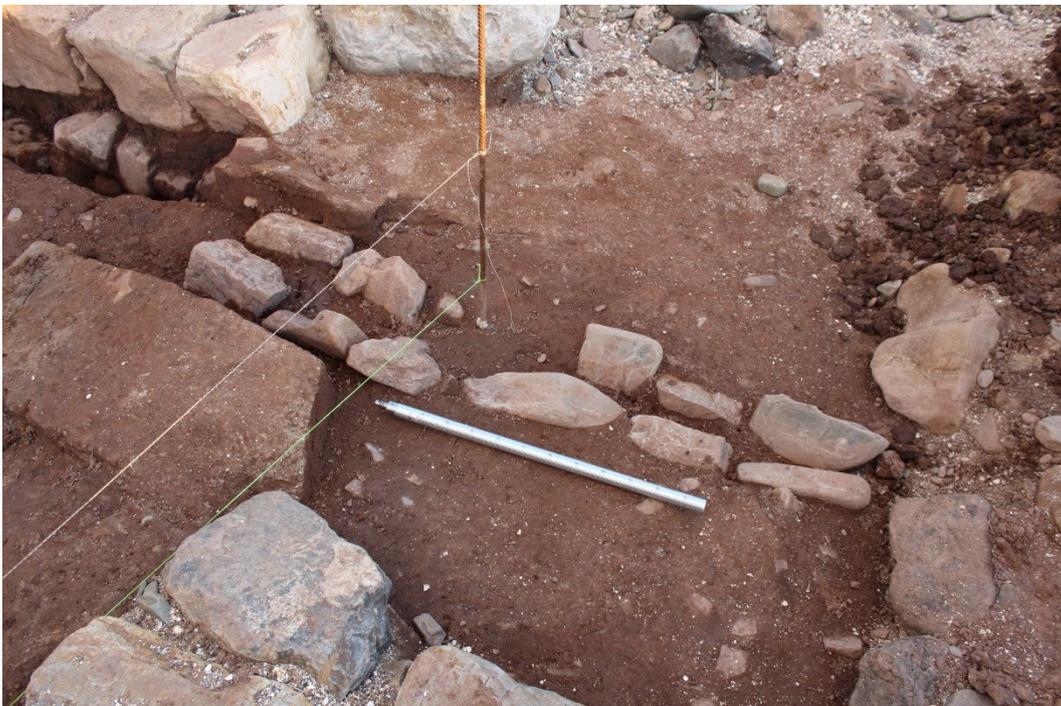
Photo 19: View southeast across southwestern corner of Building 7 showing probable drain

- 3.7.6 In the southwestern corner of the building a possible drain was identified (Photo 19), formed of a series of parallel upright slabs. Due to prior erosion, the wall did not survive above the drain.
- 3.7.7 Below the southern end wall of this building a possible earlier wall line was exposed underneath on a slightly different alignment. It was not investigated further during this phase of excavation.

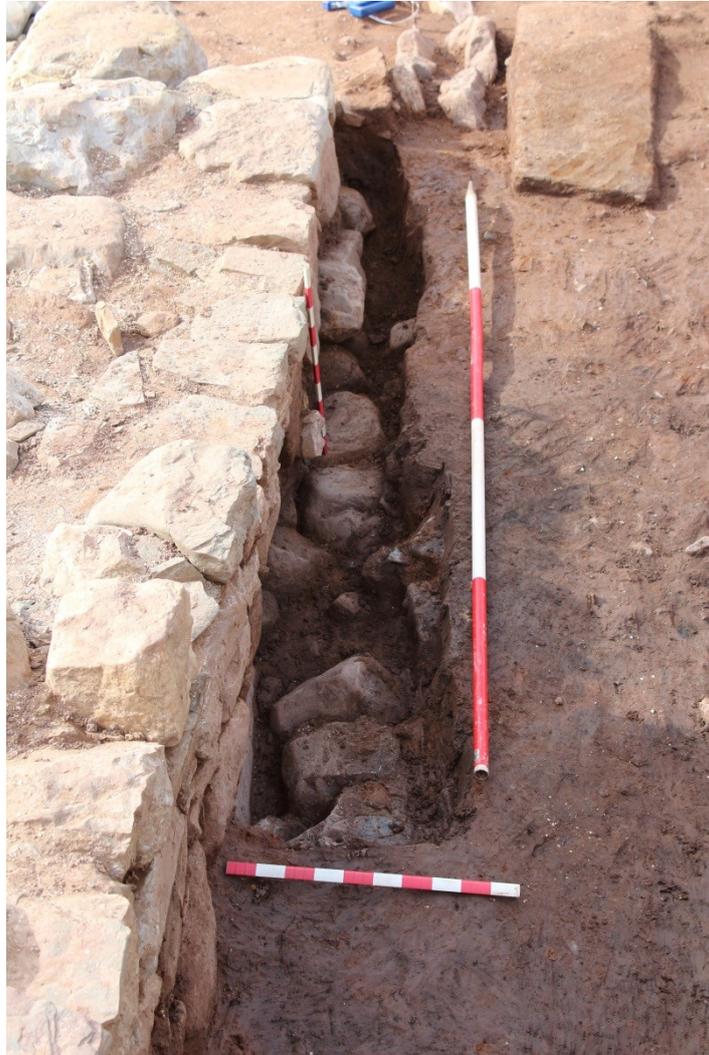
Photo 20: View west along southern wall of Building 7 showing possible wall line underlying the structure

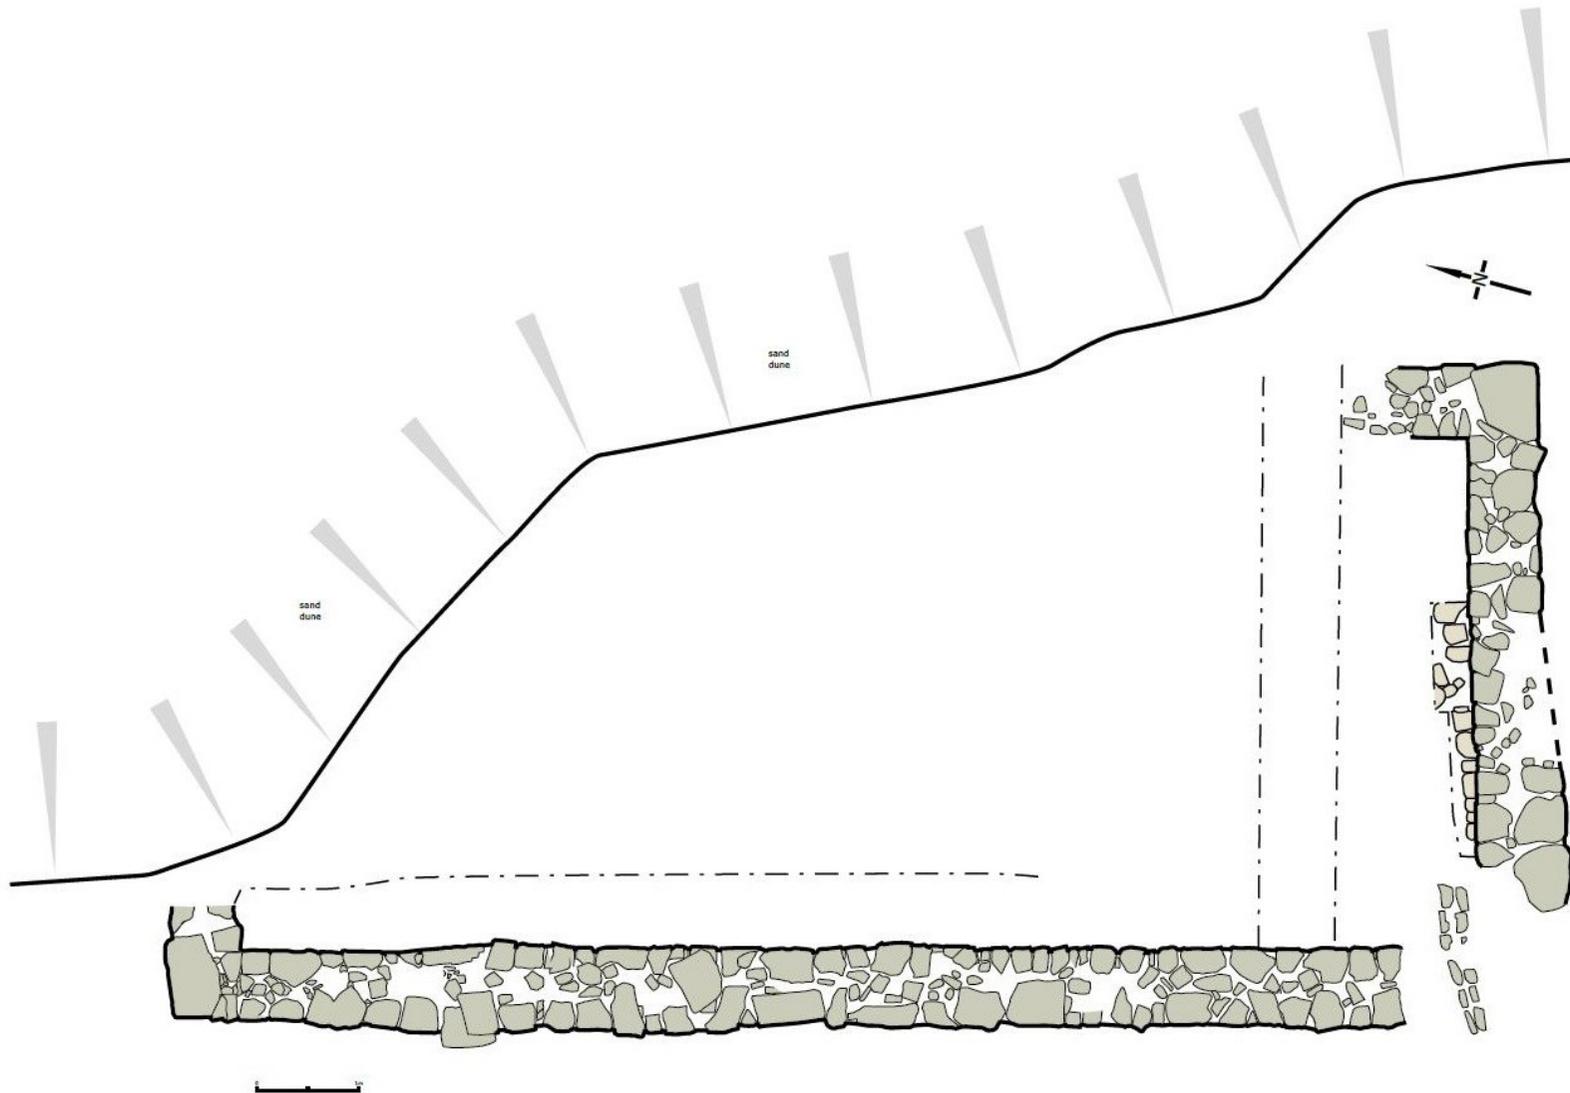
Figure 4: Plan of Building 7, showing surviving wall lines in relation to dunes, southwestern drain and possible earlier, underlying wall at southern end
