ST ISHMAEL DESERTED MEDIEVAL VILLAGE, CARMARTHENSHIRE ARCHAEOLOGICAL INVESTIGATIONS 2017 INTERIM REPORT

RHIF YR ADRODDIAD / REPORT NO. 2017/62
RHIF Y DIGWYDDIAD / EVENT RECORD NO. 111141

CADW PROJECT NO. DAT 147

Mawrth 2018
March 2018

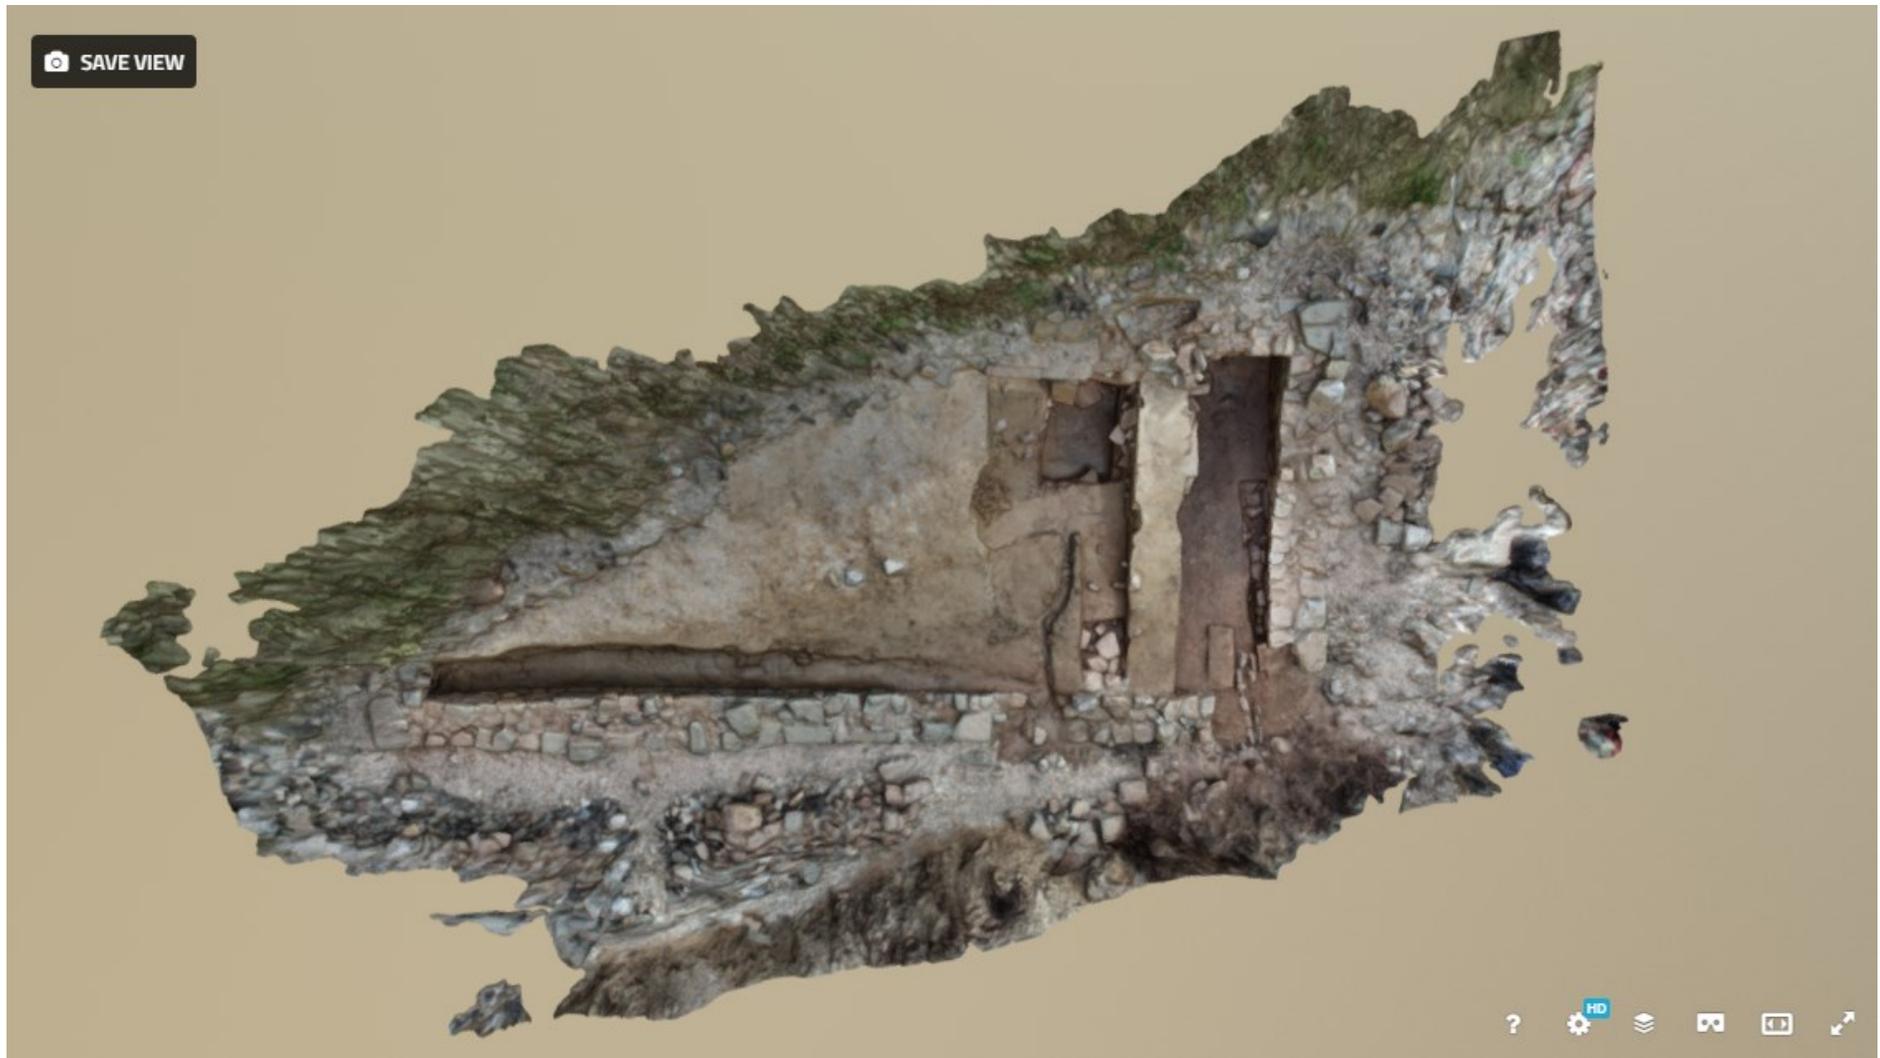
Figure 5: Photogrammetric model of Building 7 creating a virtual aerial view of the Building
Viewable via Sketchfab website <https://skfb.ly/69vtV>

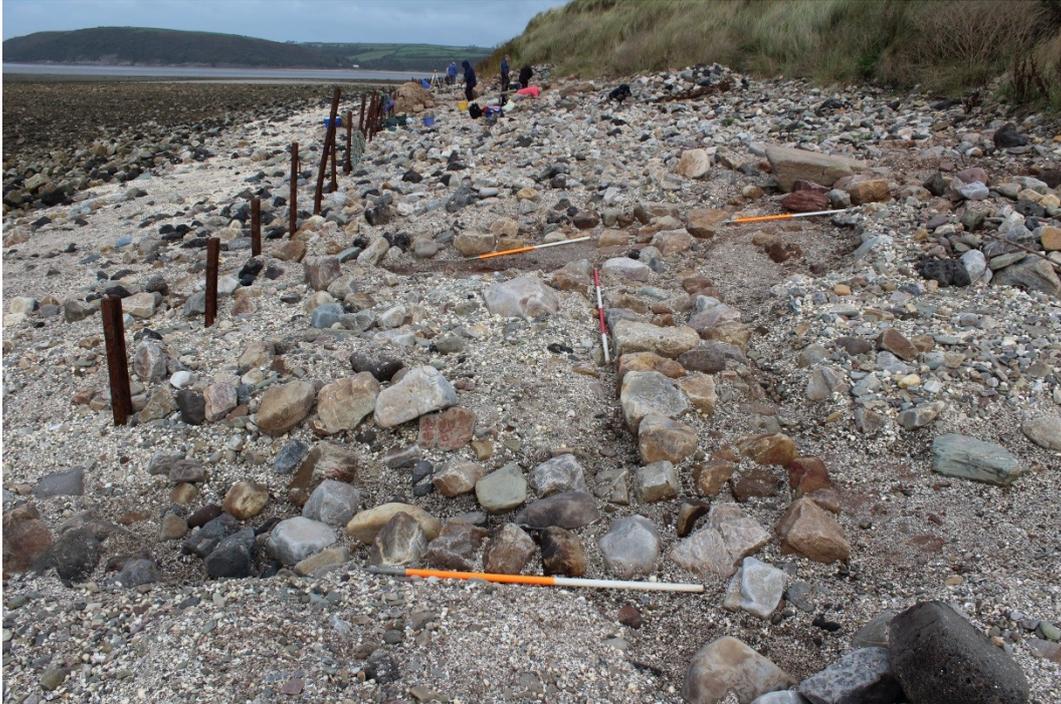
3.8.1 Building 8 survived as a series of perpendicular walls, a single course in height creating a roughly H shape (Figure 6; Photos 21 and 22). It would appear that this structure had been badly eroded as it lay closer to the tide line than Building 7.

Photo 21: Remains of Building 8 viewed from the south

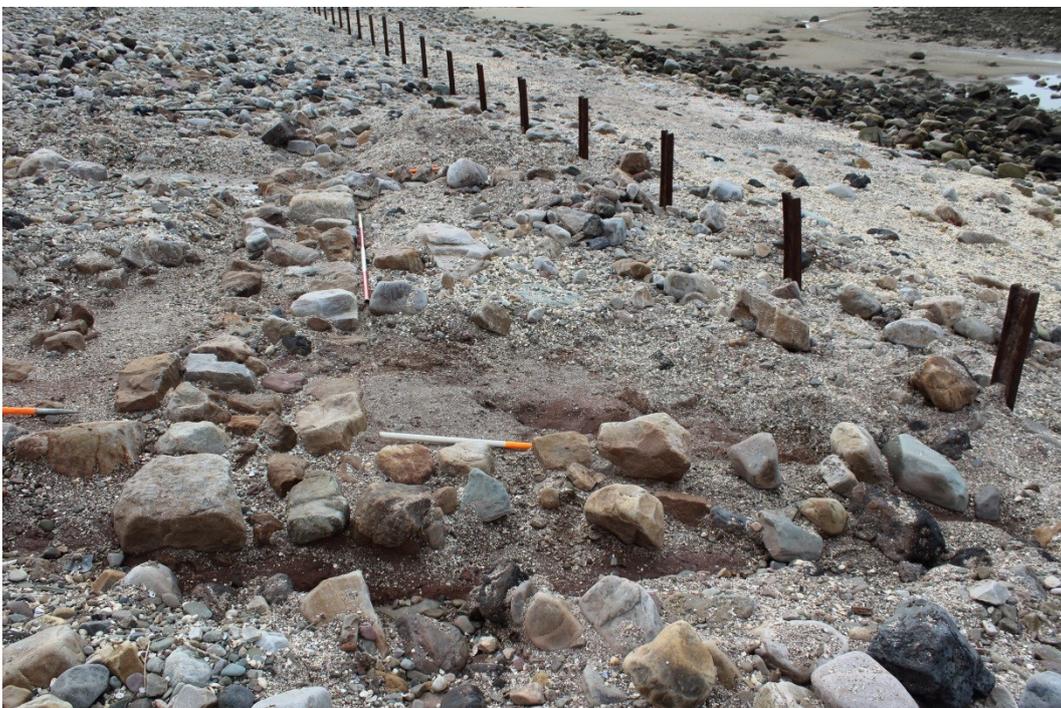
Photo 22: Remains of Building 8 viewed from the south

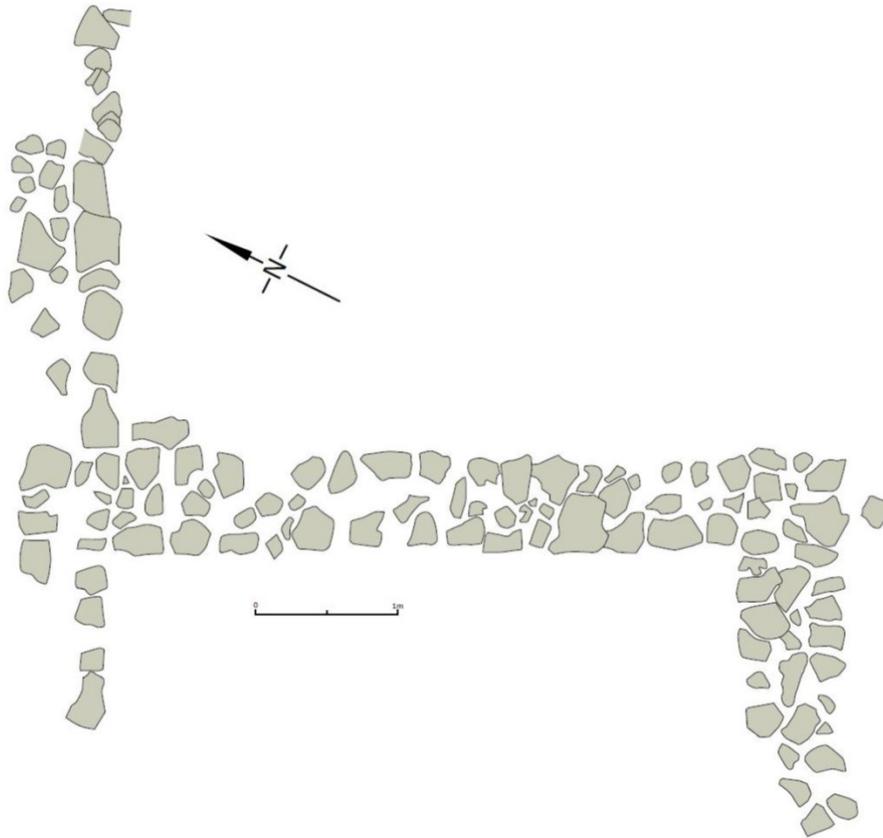
Figure 6: Plan of remains of Building 8
